JOTUN

YOUR GUIDE TO CORROSION UNDER INSULATION

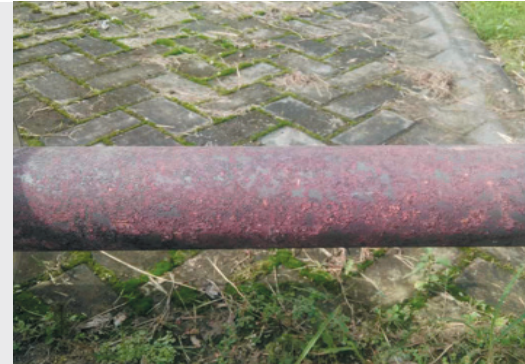
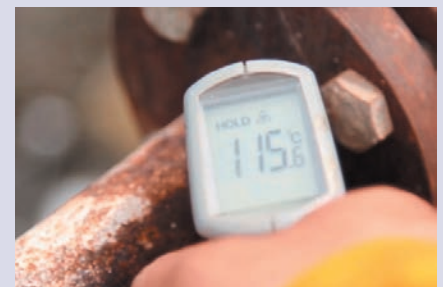
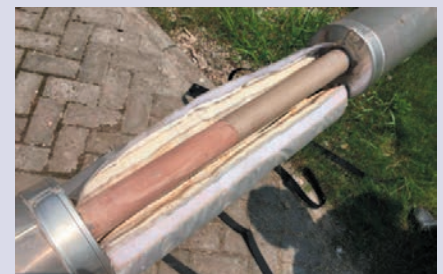
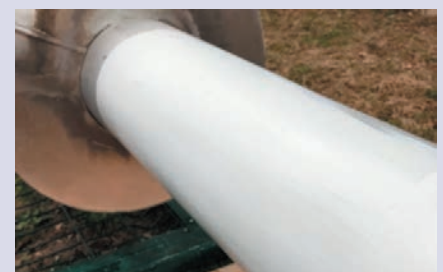
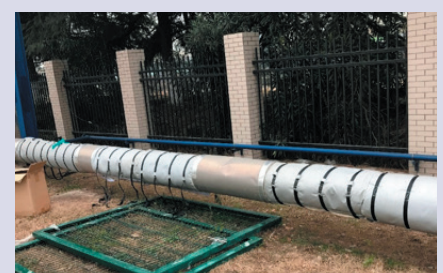
CASE STUDY

CUI was found at a factory in China when a hot steam pipe running along the site was undergoing maintenance.

The pipe had a steel surface temperature of 115 degree Celsius, and could not be brought to an ambient temperature for the coating work to occur. While the pipe was not in terrible condition, there was some surface rust and the need for paint work was present.

The pipes were prepared with a disk grinder, and a satisfactory level of surface roughness was obtained to achieve good adhesion between the paint and the substrate. Two coats of Jotatemp 250 were then applied with a brush and allowed to cure, before the insulation was re-attached to the pipe.

In order to deal with these issues, which could have escalated to a larger problem for the site, Jotun recommended its protective Jotatemp 250 for the coating.

While the operating temperature of the pipe was not very high, because Jotatemp 250 can be applied on a hot steel pipe where manual surface preparation had been carried out, it meant the pipes could be restored to a good condition without unscheduled downtime on site.
